Shield Systems Goes Green Check Out Our Step By Step CETCO Garden Roof Assembly

Roof Top of 5205 Bischoff Avenue,
St. Louis, MO 63110

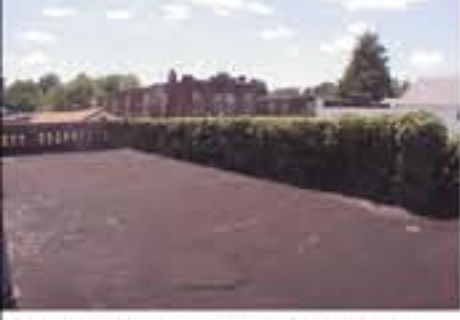
The roof top covering Shield Systems, Inc. was in need of replacement. The old built up roof had long out lived its useful life. The roof top also serves as an informal gathering place for the occupants of the two second floor apartments. It was decided to convert the area to a recreational area highlighting a living garden roof.

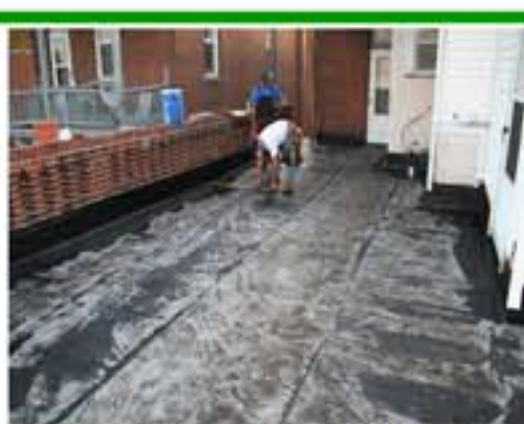
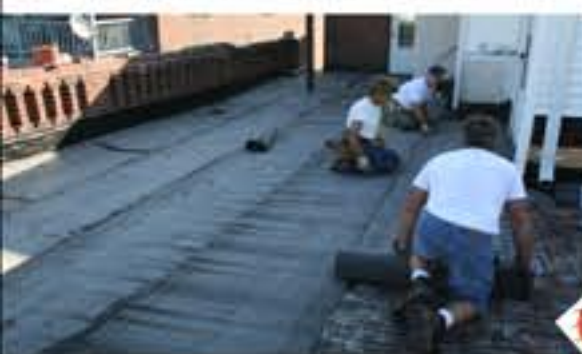
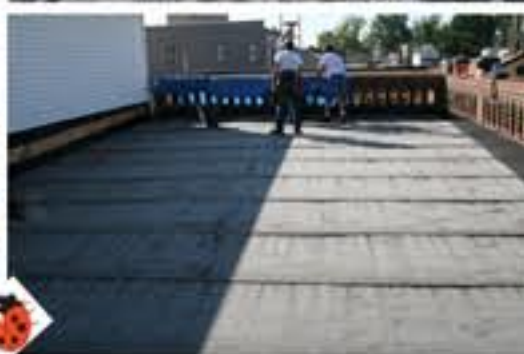
The first task at hand was to remove the existing built up roof and add new decking to receive the hot rubberized fluid applied waterproofing supplied by CETCO.

Installation of the CETCO Strataseal "HR" started with placement of 90 mils of hot rubber membrane. A reinforced scrim cloth was set into the curing rubber to add reinforcement to the elastomeric membrane. Next, a second coat of hot rubber at 125 mils was applied and a protection course was placed into the curing rubber. Because the hot rubber cures rapidly the two coat system can be performed simultaneously..

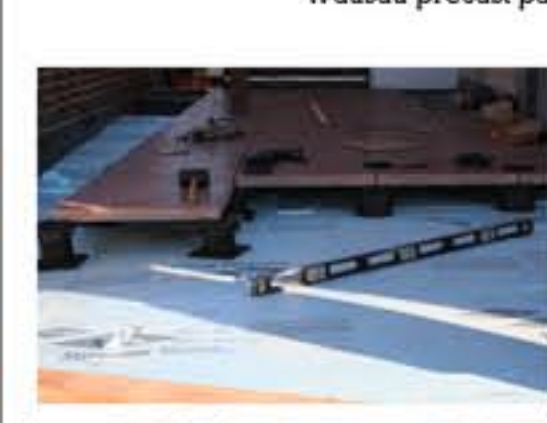
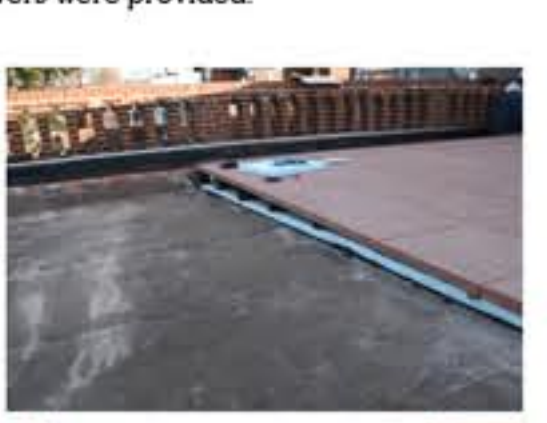
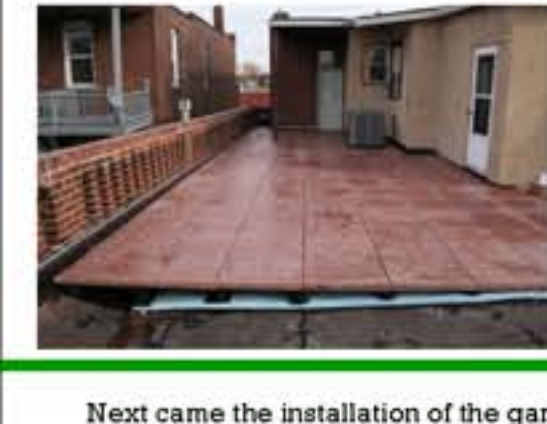
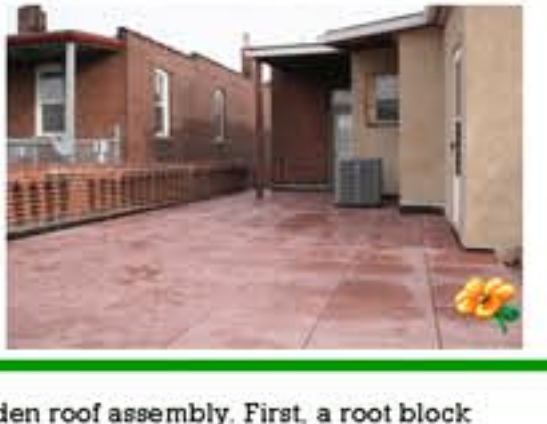
To increase energy efficiency a layer of 2" Dow Chemical Styrofoam was placed over the entire deck area. Because the insulation would receive an overburden of pavers and soil, a high density product was selected.

Immediately following the insulation layer came the placement of the paver/pedestal system. Specifically, CETCO's pedestal system allowed for leveling of the roof deck area. The pedestals are designed to handle a wide range of elevation changes and make for quick placement of the paver products. In this particular application the Wausau precast pavers were provided.

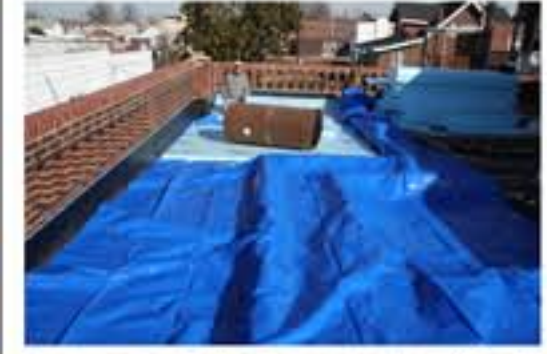
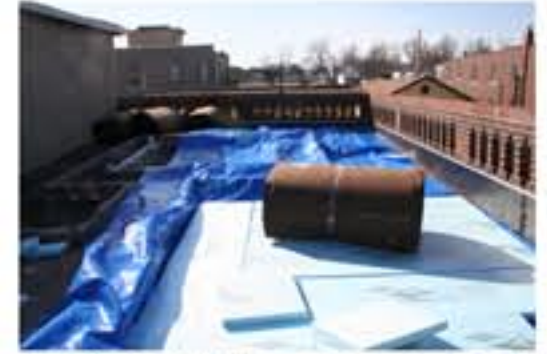
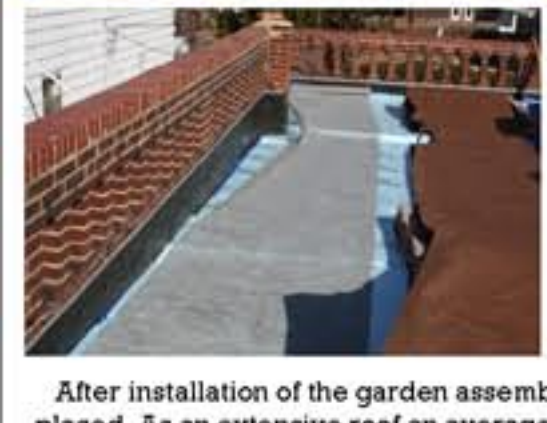
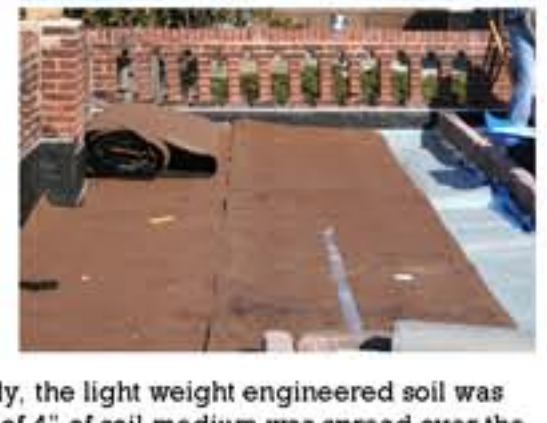
Next came the installation of the garden roof assembly. First, a root block material consisting of a heavy duty polyethylene sheet was installed. The second step called for the Dow Chemical Styrofoam insulation. To help spread loading a reinforced scrim was placed over the foam. Finally, the Aquadrain drainage layer was placed. This product serves as the water retention system for irrigation of the plant life; excess water, at the same time, is allowed to drain from the system.

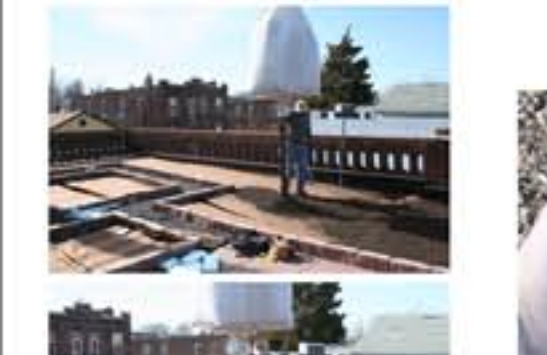
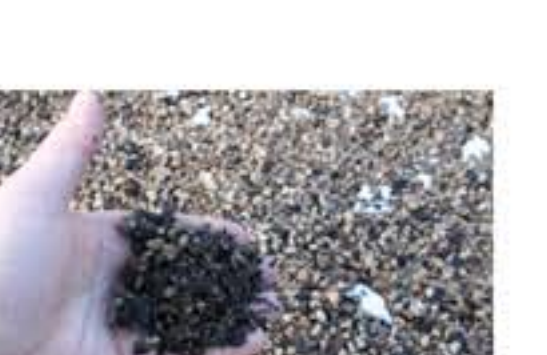
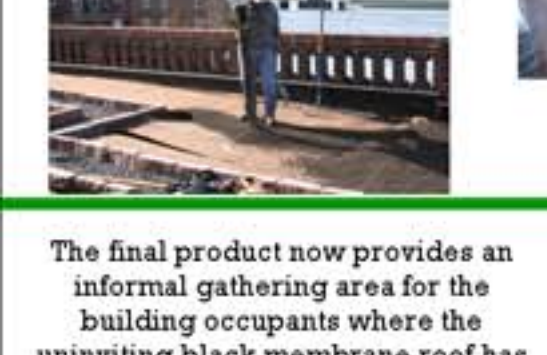
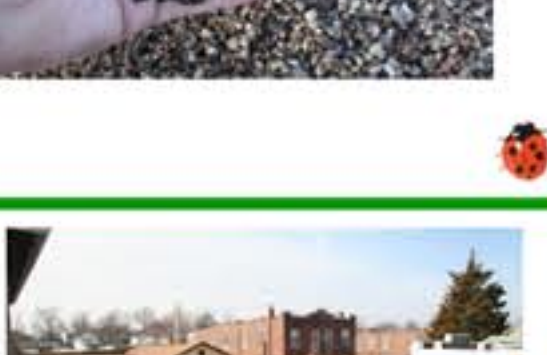
After installation of the garden assembly, the light weight engineered soil was placed. As an extensive roof an average of 4" of soil medium was spread over the garden roof area. All that awaits now is warmer weather so that the planting process can take place.

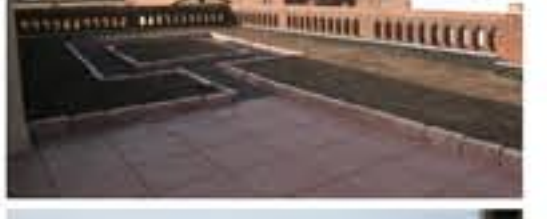
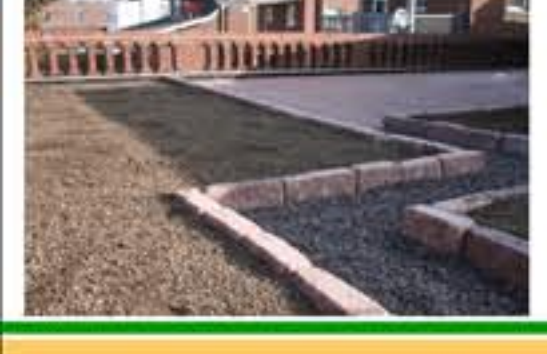
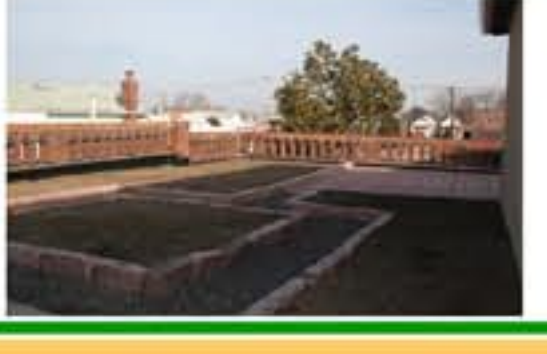
The final product now provides an informal gathering area for the building occupants where the uninviting black membrane roof has been replaced with an aesthetic, environmentally friendly space.
