# SHIELD SYSTEMS, INC.

**Project Name:** St. Luke's Hospital East Garage  
**Owner:** St. Luke's Hospital  
**Address:** 232 South Woods Mill Road  
Chesterfield, MO 63017  
**Phone:** 314-434-1500  
**Installation:** 2002  
**Materials:** Strongcote SC113  
Heavy Duty Traffic Membrane  
**Preparation:** High Pressure Water Blast  
**Application:** Squeegee/Back Roll

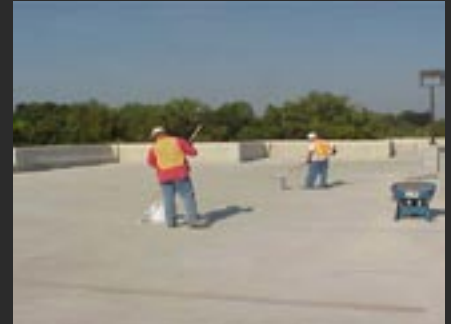
Detailing Cracks Using EM-100N

This new parking garage experienced hairline cracking on a portion of the deck due to adverse weather during the concrete pour. As a remedy, it was recommended that the hairline cracks be epoxy injected then the entire 8,500 square foot area be coated with SC-113 Heavy Duty. All hairline cracks were treated first with EM-100 membrane then coated with the Strongcote system. The entire area was treated with two coats of Strongcote the same day and opened to traffic the next.

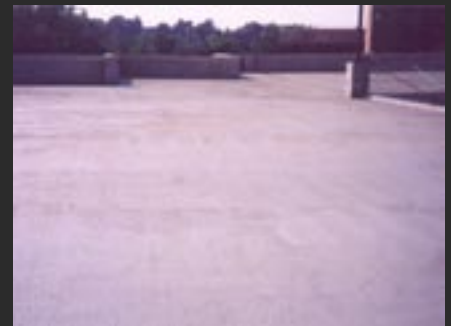
Installed System
